# Structural scheme of the Cathedral of Burgos

D. Theodossopoulos

*Institute of Architecture, School of the Built Environment, University of Nottingham, UK*

**ABSTRACT:** Structural analysis of the Burgos Cathedral was carried out in order to establish the structural scheme of the main church building. The main tool in this study was a 3D Finite Element model that simulated in sufficient detail one representative bay of the Cathedral. The model provided the opportunity to examine the behaviour of the main load-bearing elements in their real loading and boundary conditions and assess the contribution of each in the structural scheme of the building. The low level of stresses demonstrated the high reserves in strength of the original design. The analytical model can further gauge the applicability of more simplified modelling strategies for the building or parts of it, while it can also be used to examine more complex loading conditions or the origin of some more specific defects.

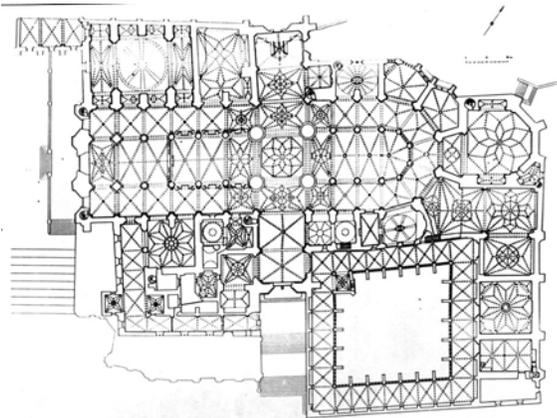
Figure 1. Plan of the Cathedral (Karge 1989)

The Cathedral of Burgos is situated at the centre of historic centre of Burgos. Extensive research on the function of the main structural elements and their construction sequence can be found in (Rico 1985, Andrés 1993, Karge 1989, Martinez 1866, Torres Balbás 1952). The entire complex is supported on the slope of the citadel hill and a series of underground chapels. The main church is a Latin cross in plan, arranged in a nave and two aisles (Fig. 1). Longitudinally, the church is enclosed and fixed by a façade characterised by a rich decoration that incorporates deep buttresses and spires that crown

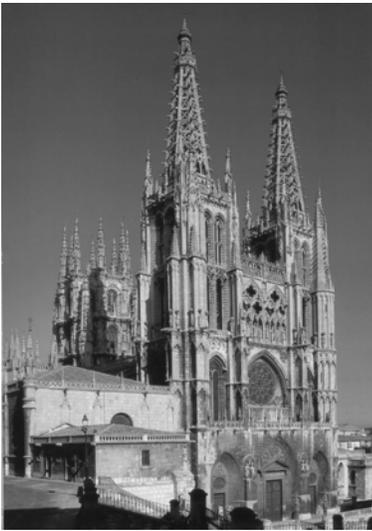
Figure 2. External aspect of the Cathedral (Andres 1993)

the two towers (Fig. 2). On the east end, the structure is retained by the ambulatory, to which the large chapel of the Constables of Castile is added, while the two-level cloister braces the SE quarter.

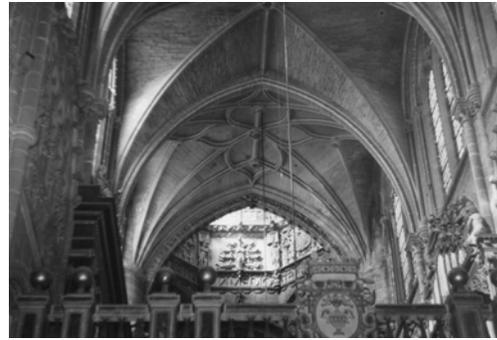
Figure 3. The interior of the Cathedral

The crossing tower (Fig. 3) is a focal point of the scheme not only because of its position, volume and decoration but also due to the major reconstruction of the entire crossing area its collapse caused in 1539. The heavy pilasters that were then incorporated provide further stiffness to the ends of the choir and the nave and to some extent compartmentalise structurally the building.

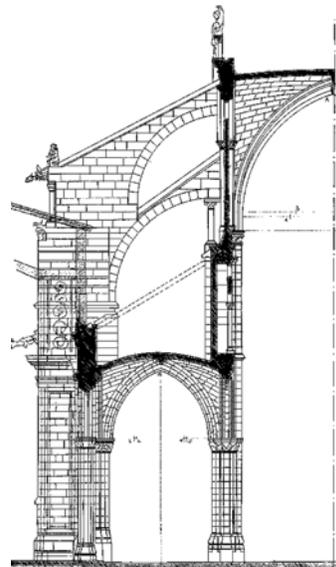
Figure 4. Cross section of the nave – third bay from the facade

The elevation of the nave follows the typical division into nave arcade, triforium and clerestory (Fig. 4) and the differences with that of the choir are mainly stylistic. The compound piers are formed by a cluster of 8 shafts that join the ribs of the vaults above, providing an aesthetic unity that will be discussed later. The nave arcade is a pointed arch with a not very deep section, which means the *tas-de-charge* ending of the wall above has a large offset (Fig. 4). As a consequence, the blind triforium passage formed behind a single arch span is quite shallow. The top windows occupy the most part of the clerestory but apparently they do not compromise the lateral stability of the wall as will be seen below.

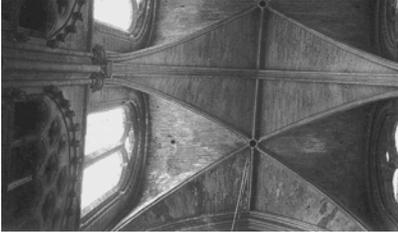
(a) Nave vault

Figure 5. The main vaulting types of the Cathedral

The dimensions of the elevation however depend significantly on the vaulting system. Quadripartite ribbed cross vaults of good quality ashlar masonry were used, following the French type bond of laying the units in courses parallel to the edges. The vaults in the nave (Fig. 5a) span over a 5.3 x 10.4 m compartment. The longitudinal vertex is emphasised by a rib that runs along the main axis of the nave, while the vaults next to the transept and the façade are formed by a more complex net of tierceron ribs (Fig. 3). An interesting feature of the transverse vault is that it is stilted, so the corresponding thrusts are applied with an offset from the springing.

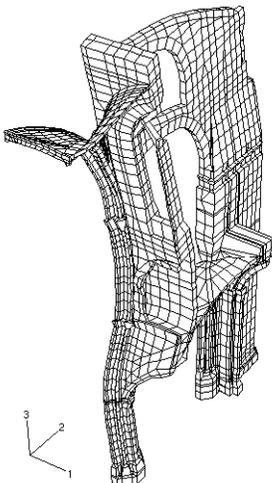
Figure 6. Deformation under self weight of a bay at the nave (magnified 300 times)

A linear elastic analysis was performed under self weight of the materials. The resulting deformation of the FE model (Fig. 6) and the stresses, as will be discussed below, are generally low and this indicates the efficiency of the design of the building, in response to the high compressive strength of the constitutive materials and elements.

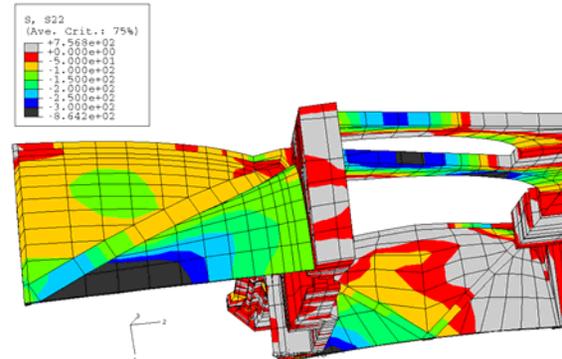
Figure 7. Stresses S22 at the upper surface of the nave (in kN/m<sup>2</sup>)

However, the central portion of the vault still tends to spread outwards. The stiffer transverse web transmits most of this horizontal deformation onto the wall and tension develops there mainly at the area between the vault and the crown of the clerestory window (Fig. 8). As a consequence, compression results along the straight vertex of the transverse vault, which diminishes closer to the wall.

This torsion affects the entire vault and a similar pattern develops in the other direction as well (Figs. 7 and 13). If the two patterns are examined together, an in-plane, shear deformation appears to develop due to the torsion of the vault. This rotation can be associated with the deformation of the upper structure due to the apparently excessive thrust from the flying buttresses observed earlier. The lateral wall seems to have sufficient stiffness to transmit most of this deformation directly on the aisle.

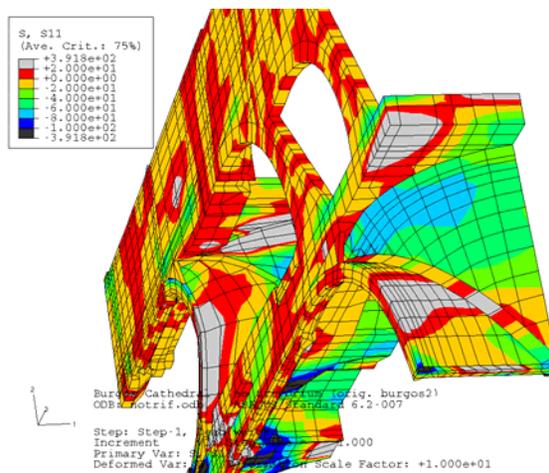
Figure 8. Stresses S11 (in kN/m<sup>2</sup>)

The relative stiffness of the transverse web is further demonstrated by the mainly compressive low hoop stresses (Fig. 8). The increasing values at the haunches indicate a part of the weight of the vault is indeed supported by the rib and subsequently the springing. The associated thrust twists the longitudinal web, causing longitudinal tension at most part of this area (Fig. 8).

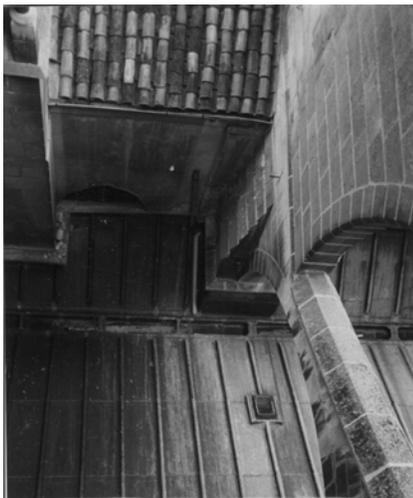
Figure 9. Aspect of the flying buttresses of the nave

So far as the flying buttresses are regarded (Fig. 9), the relatively high hoop compressive stresses at their top edge and tensile stresses at the bottom edge, at the area where they abut the wall, indicate

that both the arches perform their function to provide a thrust against that of the nave vault. In this sense, the spandrel fill is essential for the function of the lower arch as it provides a wider area for the application of the thrust. However, the counteraction seems to exceed the thrust of the vaults, especially at the upper tier. It has been demonstrated that the role of this arch is to contain thrusts developing due to wind (Bork 1997), therefore these stresses are expected to reduce reasonably.

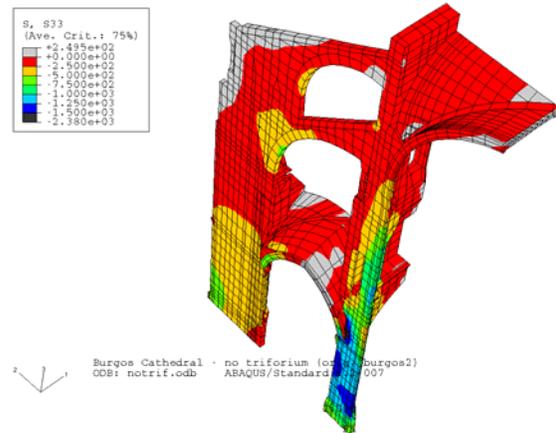
Figure 10. Vertical stresses S33 (in  $\text{kN/m}^2$ )

The triforium enclosure in itself has not been modelled, except from the arcade, as it is more of a decorative screen with no real load-bearing capacity. The decay observed today in some of the mullions is mainly due to differences in temperature and humidity and every damage should rather be classified as a serviceability defect. Fig. 10 shows also the flow of forces around the triforium arch and the concentration of compressive forces at the extension of the pier. The maximum stresses in this area ( $1 \text{ N/mm}^2$ ) are still below the compressive strength.

The combination of the in-plane rotation of the vault with the eccentrically transmitted vertical loads of the upper structure is somehow beneficial for the arcade pier that ultimately supports these loads. Despite the relatively higher compressive stresses, the variation of the vertical loads in the section is not strong and they appear to be transmitted axially (Fig. 10). The attached shafts and the base of the pier reduce the stresses, which stay in any case below  $f_c$ . So far as the pier buttress is regarded, the weight of the pier has managed to reduce significantly the overturning effect of the thrusts from the flying buttresses and the aisle. The bending stresses due to the offset with which these forces are transmitted to the ground are contained within the limits of strength (Fig. 10).

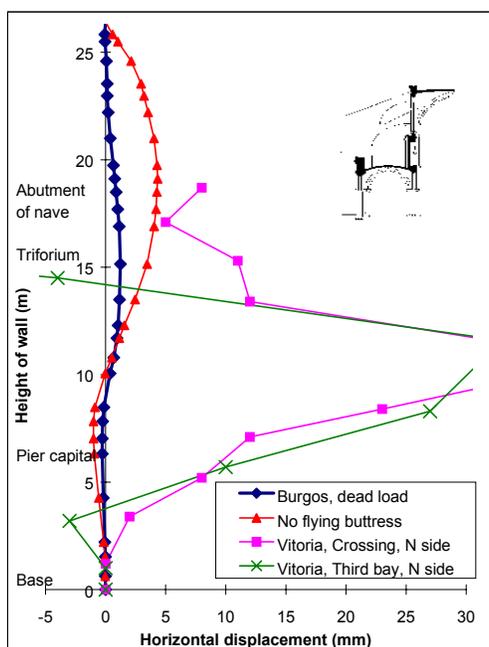
Figure 11. Lateral deformation of the pier extension

The behaviour of the lateral wall can also be illustrated by the deformation of the pier extension (Fig. 11), in particular the shaft from the compound pier that runs continuously until the crown (Fig. 5). The diagram ("Dead load") shows clearly the hinge that can be formed at the *tas-de charge*, at 9m height. However, further above, the inward displacement at the middle of the nave arch highlights the effect of the thrust of the flying buttress on the nave, although the values are relatively small. In order to show the proportions of this problem, a comparison is made with the heavily deformed bays of Santa Maria la Vieja, the Old Cathedral of Vitoria (Azkarate 2001). These deformations were recorded through a monitoring programme and are attributed to the lack of flying buttresses from the original project and their belated addition once the nave of that Cathedral had started spreading.

The lateral displacement of the bay has increased as the higher inward deformation of the nave vault shows in Fig. 11. The values however do not compare with the magnitude of the deformations observed in Vitoria Cathedral, which must have been affected by time-dependent decay of the joints and the incorrect location of buttressing systems once the deformations became appreciable.

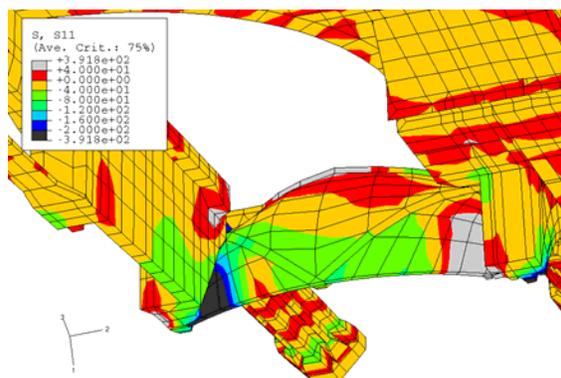
Figure 12. Stresses S11 at the extrados of the aisle vault (in  $\text{kN/m}^2$ )

The main actions on the aisle vault are the self weight of the masonry and the loads from the upper structure applied asymmetrically over the arcade only. The vault is contained between the pier arcade and the pier buttresses and therefore the lateral thrusts are not contained in the same symmetrical manner as in the nave vaults. Both vertices are curved and this domical pattern was probably chosen intuitively to reduce bending as will be discussed later.

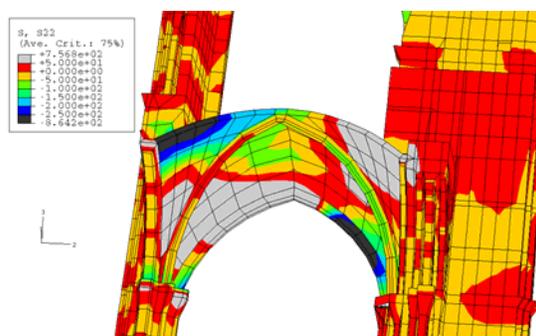
Figure 13. Stresses S22 at the intrados of the aisle vault (in  $\text{kN/m}^2$ )

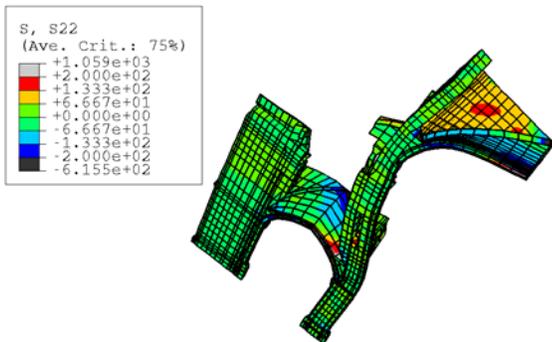
Figure 14. Stresses S22 at the structure after the flying buttresses have been removed ( $\text{kN/m}^2$ )

Using the same FE model, the role of the flying buttresses and the successive construction phases of the building have been studied by removing both tiers (cf. Croci et al 1995). The resulting stress

pattern (Fig. 14) is characterised by the high compressive stresses developing in a wider area of the nave vault, while the transverse web in this area is now in tension. The aisle vault still follows the deformation of the nave with an in-plane twist, but now the shear forces effect is more pronounced in one direction as wider section of the transverse vertices are now involved.

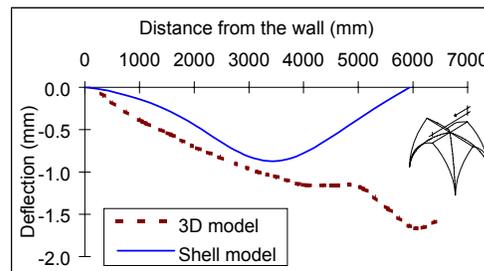
Figure 15. Deflection of the vertex of the aisle

Another interesting area to be investigated is the behaviour of the cross vaults. The aisle cross vault was modelled separately in more detail and both the webs and the ribs and arches were generated by shell elements, following a method outlined in (Theodossopoulos 2003). At this model, the nave arch is sufficiently stiff to provide an almost symmetrical support to the vault. The original conditions of the building, i.e. the weight from the upper structure on the arcade, as was also mentioned there, change completely the deformation of the front area of the vault (Fig. 15), with the nave arcade at the front deflecting the most.
